# Manhole Inspection Summary

Manhole # S19G\_\_035MH

Insp Date: **9/20/07 11:10 AM**

**Location** Address: **2211 LEXINGTON-VINE**

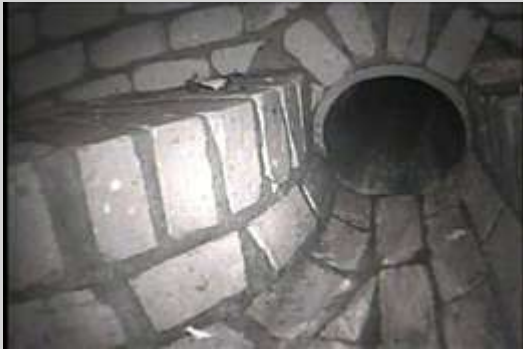
12 O'Clock Outflow

8 in. Circular Gravity Sewer  
Pipe Out @ 12 O'Clock

Pipe Height: **7.2** (in.) Rod and Bar (Angled)  
Pipe Material: **Clay** ☐ Pipe Lined  
Invert Depth: **10.53** (ft.) Flow Characteristics: **Slow**  
Deposits: ☒ None ☐ Mud ☐ Sludge ☐ Debris ☐ Grease  
Silt Depth: (in.) Deposits Extent:  
Infiltration: **None** Pipe Seal Cond: **Sound**

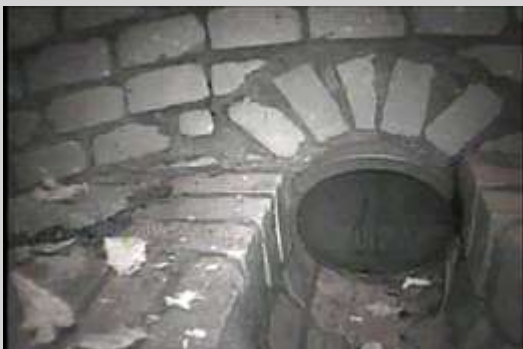
6 O'Clock Inflow

8 in. Circular Gravity Sewer  
Pipe In @ 6 O'Clock

Pipe Height: **8.4** (in.) Rod and Bar (Angled)  
Pipe Material: **Clay** ☐ Pipe Lined  
Invert Depth: **10.21** (ft.) Flow Characteristics: **Slow**  
Deposits: ☒ None ☐ Mud ☐ Sludge ☐ Debris ☐ Grease  
Silt Depth: (in.) Deposits Extent:  
Infiltration: **None** Pipe Seal Cond: **Sound**

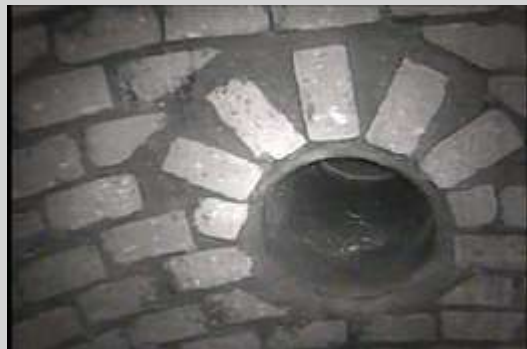
9 O'Clock Inflow

Pipe In @ 9 O'Clock

Pipe Height: **7.2** (in.) Rod and Bar (Angled)

Infiltration: **None** Pipe Seal Cond: **Sound**
